## CASE STUDY

# Motor Bearing Failure Due to Induced Shaft Voltage

In the year 2000, a major facility located near the Honolulu International Airport went through major air-conditioning and lighting systems renovations. The air-conditioning upgrade of the project involved the conversion of constant chilled water flow to variable primary flow and from a constant air volume system to a variable volume air distribution system. These new variable flow systems employed adjustable speed drives (ASDs).

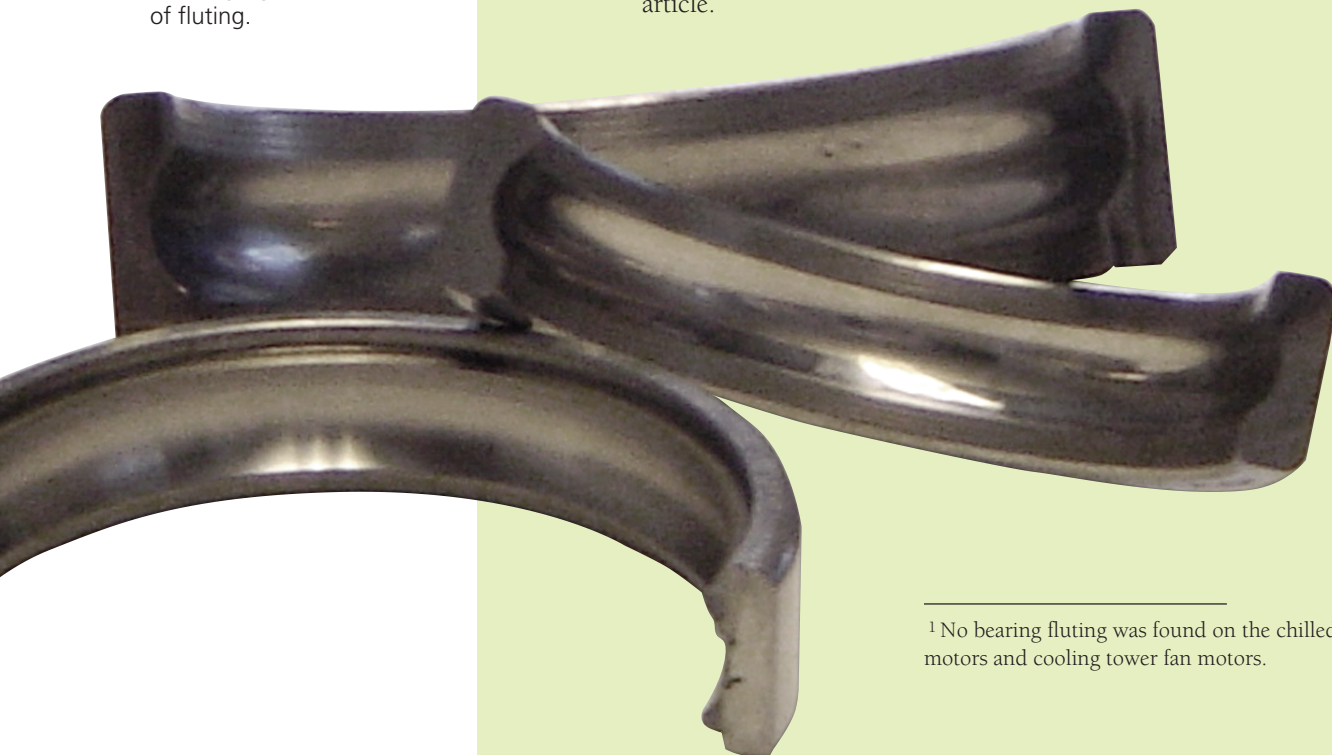
Each month thereafter, the facility experienced at least two motor bearing failures, which was unusual. The local motor supplier began blaming the failures on pulley mis-alignment and lack of maintenance. Motors from different motor manufacturers were also tried without success. HECO decided to call the original ASD manufacturer directly and found an engineer who was familiar with the problem. Prior to the engineer’s visit to the site, samples of the failed bearing assemblies were sent to the ASD manufacturer’s local representative for analysis. By cutting the bearing races in half, the representative found that the bearing races exhibited the characteristic “fluting” that results from common-mode current discharge through the bearings. Slight frosting on the surface of the bearings was also evident, although, this is a bit difficult to observe in the photos in this article.

Fig. 1:  
Bearing races  
showing signs  
of fluting.

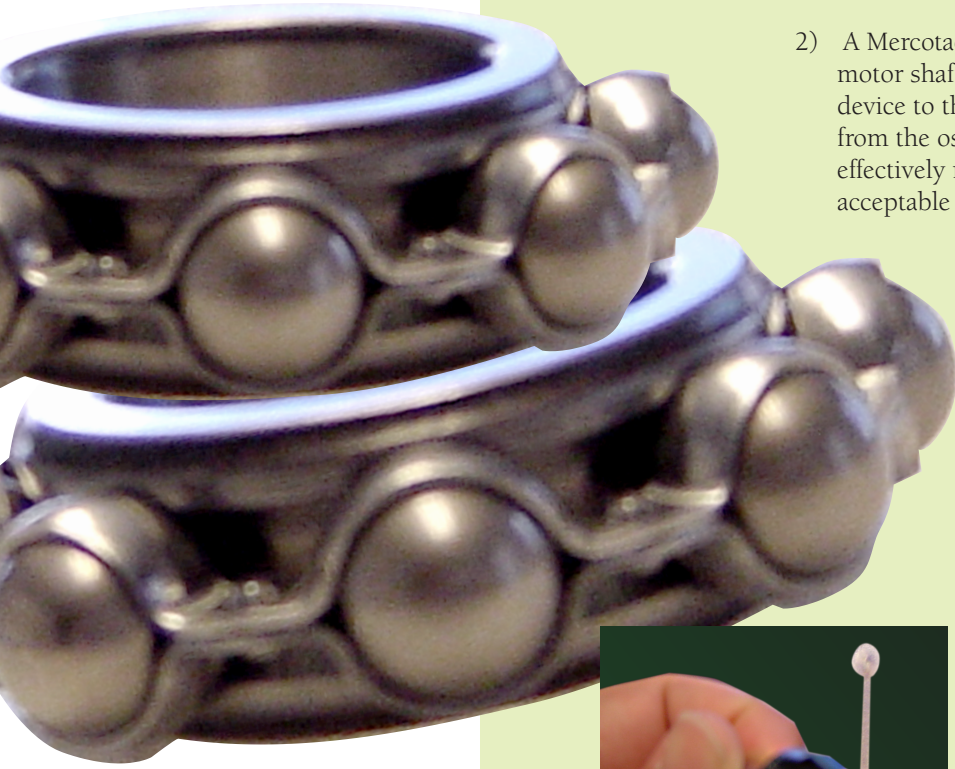
Fig. 2: Bearings beginning to show signs of surface "frosting"

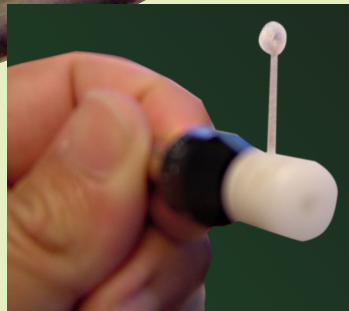
Fig. 3: Mercotac™ 110-T grounding device

- 1) A common mode reactor was placed on all three-output conductors between the ASD and the motor power terminals. No reduction in shaft voltage or common-mode current was observed.
- 2) A Mercotac™ 110-T grounding device was installed on a motor shaft. A grounding wire connects the grounding device to the base of the air-handling unit and a reading from the oscilloscope confirmed this grounding device effectively reduced the level of the shaft voltage peak to an acceptable level.

The ASD manufacturer issued a written report of their findings and recommended that this shaft grounding device be installed on all the motors.

The Mercotac™ device is basically a conductive grommet that is installed into the center of a hole drilled into the shaft end (preferably on the non-pulley side of the motor)<sup>2</sup>. The grommet makes contact with a stationary terminal lug that is soldered to a wire connected to the grounded motor casing or other nearby ground point. The Mercotac™ 110-T grounding device is preferable to carbon brush type grounding systems as the brushes must be monitored for wear and replaced frequently. The cost of the Mercotac™ 110-T device itself is approximately \$35; a small price to pay to avoid premature bearing failure!
